Dutch East India Company Shipbuilding

THE ARCHAEOLOGICAL STUDY OF
BATAVIA AND OTHER SEVENTEENTH-
CENTURY VOC SHIPS

Wendy van Duivenvoorde

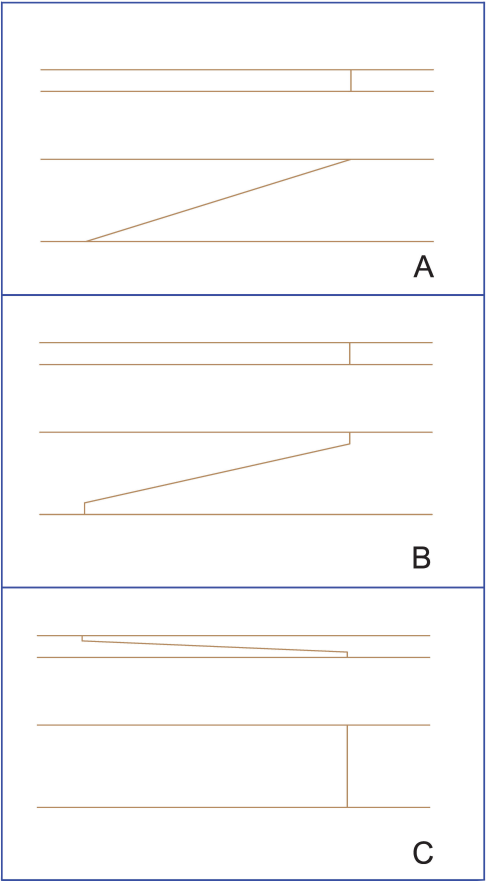
TERMINOLOGY FOR THE SCARF JOINTS DESCRIBED

Throughout this book, the different scarf joints utilized in *Batavia's* construction will follow the terminology provided by J. Richard Steffy, *Wooden Ship Building and the Interpretation of Shipwrecks*, 292: A, diagonal scarf; B, flat scarf; and C, vertical flat scarf. The author acknowledges the many other terms used for different styles of scarfs.

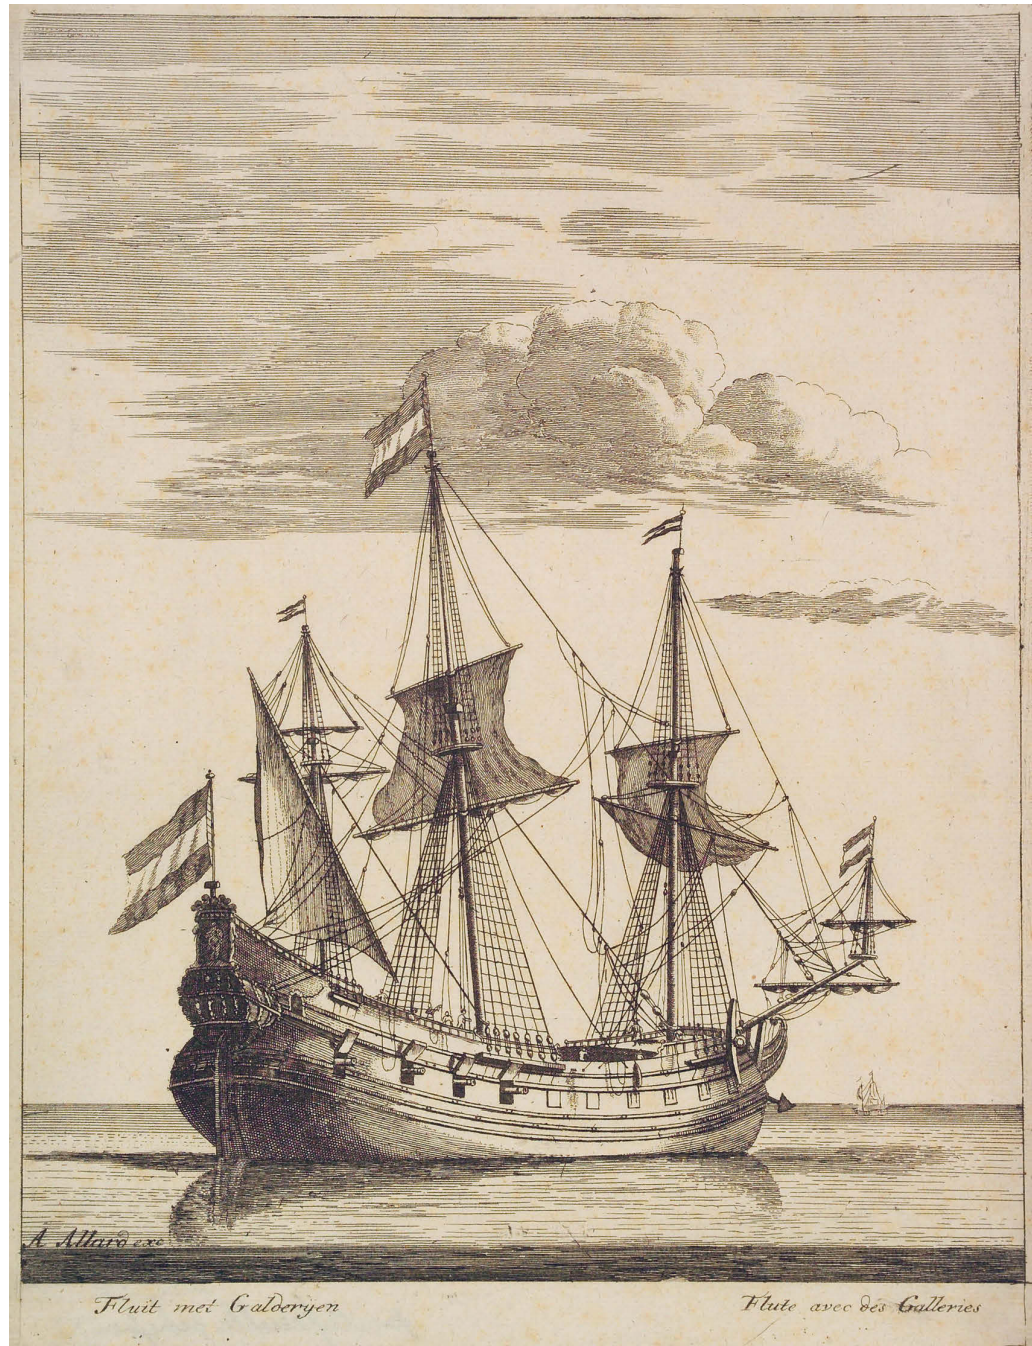
The seventeenth-century flute had a narrow top and upper stern with a round tuck and typically three wales girdling the sides of the ship below the level of its helm port. This hull form, pear shaped in cross section, is also referred to as turret built or kettle bottomed (fig. 2-2). The characteristically narrow main deck and poop contrasted sharply with the bulky cargo hold below; the maximum breadth of the ship lay below the waterline. Flutes had an average cargo carrying capacity of approximately 200 tons around 1600, which increased during the course of the seventeenth century to 360 tons.⁴¹ Flutes had a shallow draft and a relatively high length-to-beam ratio of 4:1 or more, although this was also characteristic for other ship types. *Batavia*, for example, being an Indiaman, had a similar length-to-beam ratio of 4.4:1.

FIGURE 2-2. Flute ship with narrow upper deck and three wales below the helm port. Engraving by Abraham Allard, 1650, National Maritime Museum Amsterdam (A.0149-562).

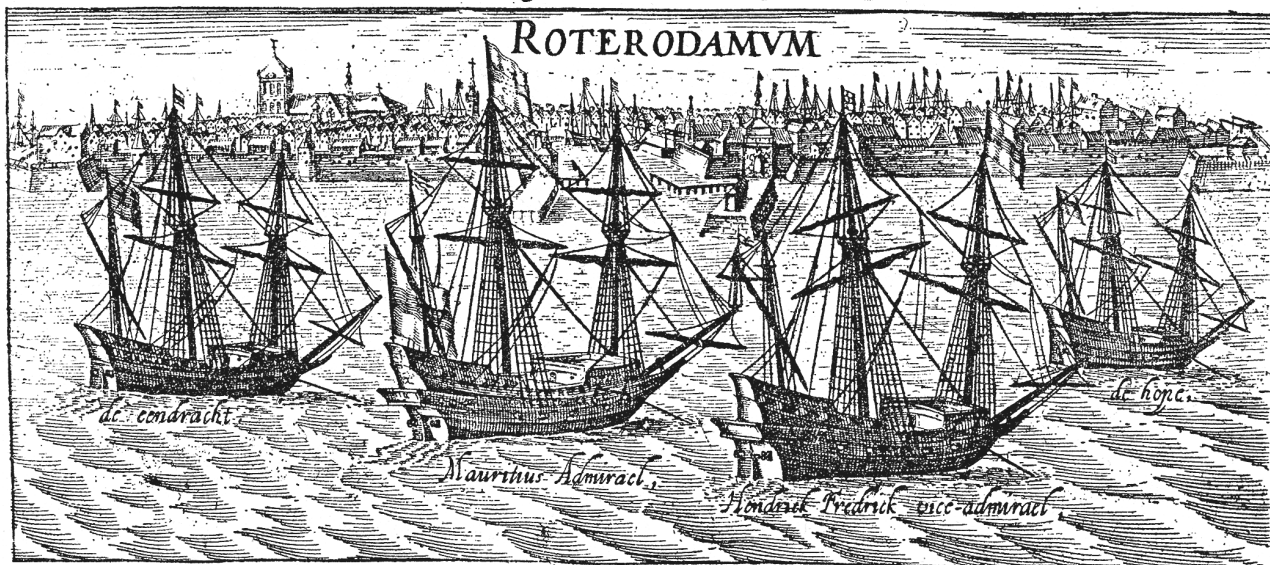
FIGURE 2-4. Three Indiamen and one yacht (right) with a flat transom and a square tuck. Illustration by Jan W. IJzerman, *De Reis om de Wereld door Olivier van Noort*, title page.

world with Olivier van Noort from 1598 to 1601 (fig. 2-4).⁸¹ Furthermore, the earliest VOC construction charter (1603) or contract for 160-ton yachts refers specifically to the size of the wing transom, which shows that yachts were built with a flat transom.

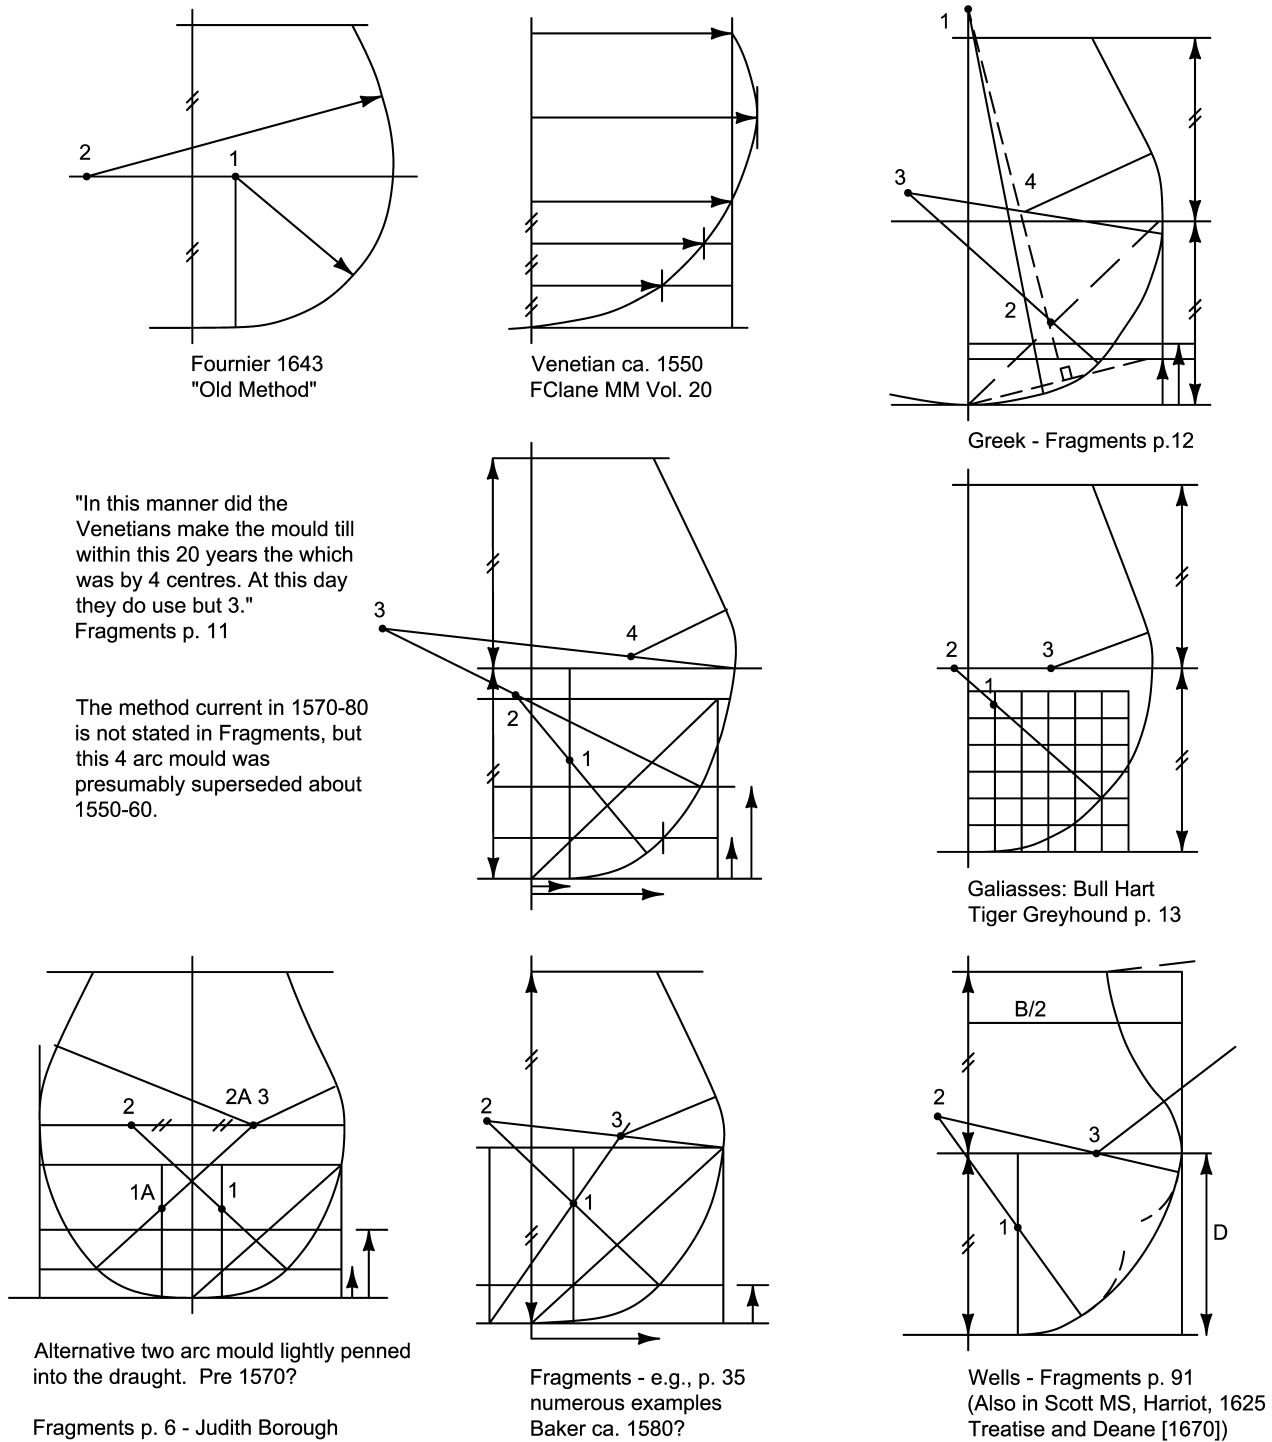
FIGURE 2-5. Selected midships molds. Illustration after Barker, "Fragments of the Pepysian Library," fig. 3.

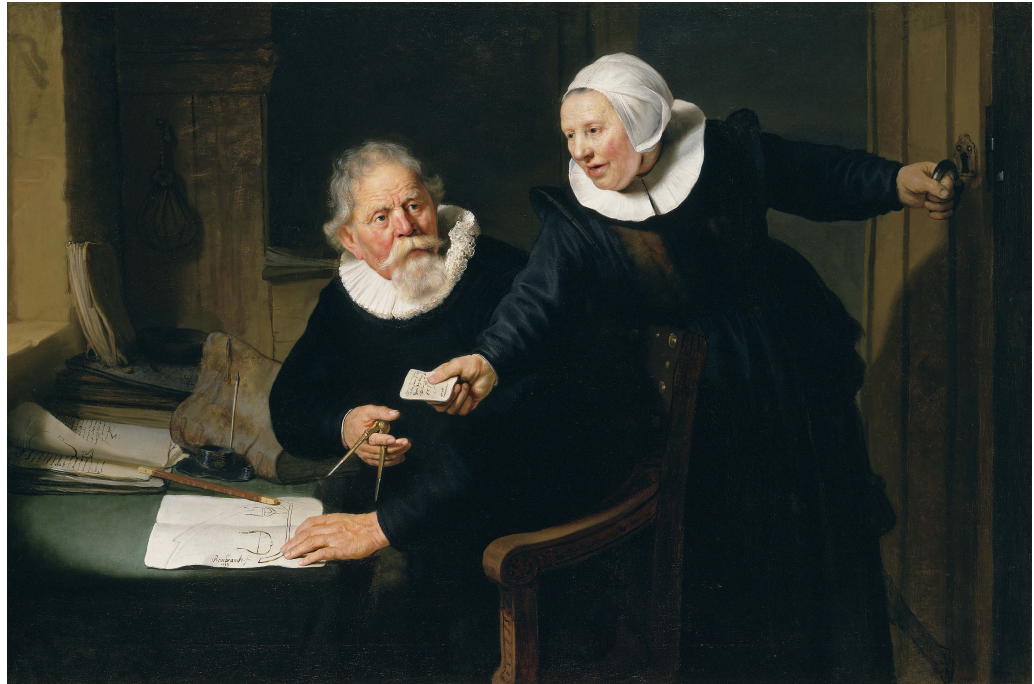
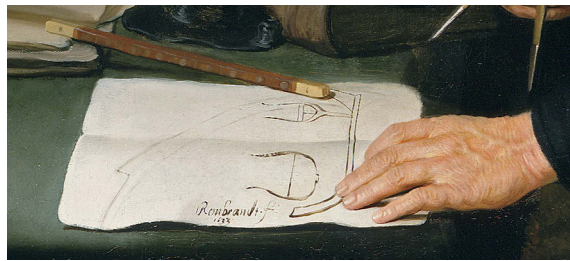
FIGURE 2-7. Detail showing ship's central
spine and master frames. Painting by
Rembrandt van Rijn, Royal Collection, Queen's
Gallery, Buckingham Palace, London, 1633
(RCIN 405533). The Royal Collection © 2008,
Her Majesty Queen Elizabeth II.

Dutch shipwrights were familiar with the use of midships molds in foreign frame-based ship construction, the use of compasses to draw curves, and application of proportional relations to design mold frames, as is evident in Rembrandt's 1633 painting of VOC shipwright Jan Rijcksen and his wife, Griet Jans (fig. 2-6). In this painting, Rijcksen holds a pair of compasses or dividers in his hand, and on his drafting paper a midships section or master frame, central spine, and transom are depicted (fig. 2-7). This resembles the midships mold design methods of the French and English as discussed by Baker. It is noteworthy to see Rijcksen with a pair of compasses and such a design on paper because he worked in Amsterdam, where bottom-based construction predominated in shipyards at the time Rembrandt made his portrait.

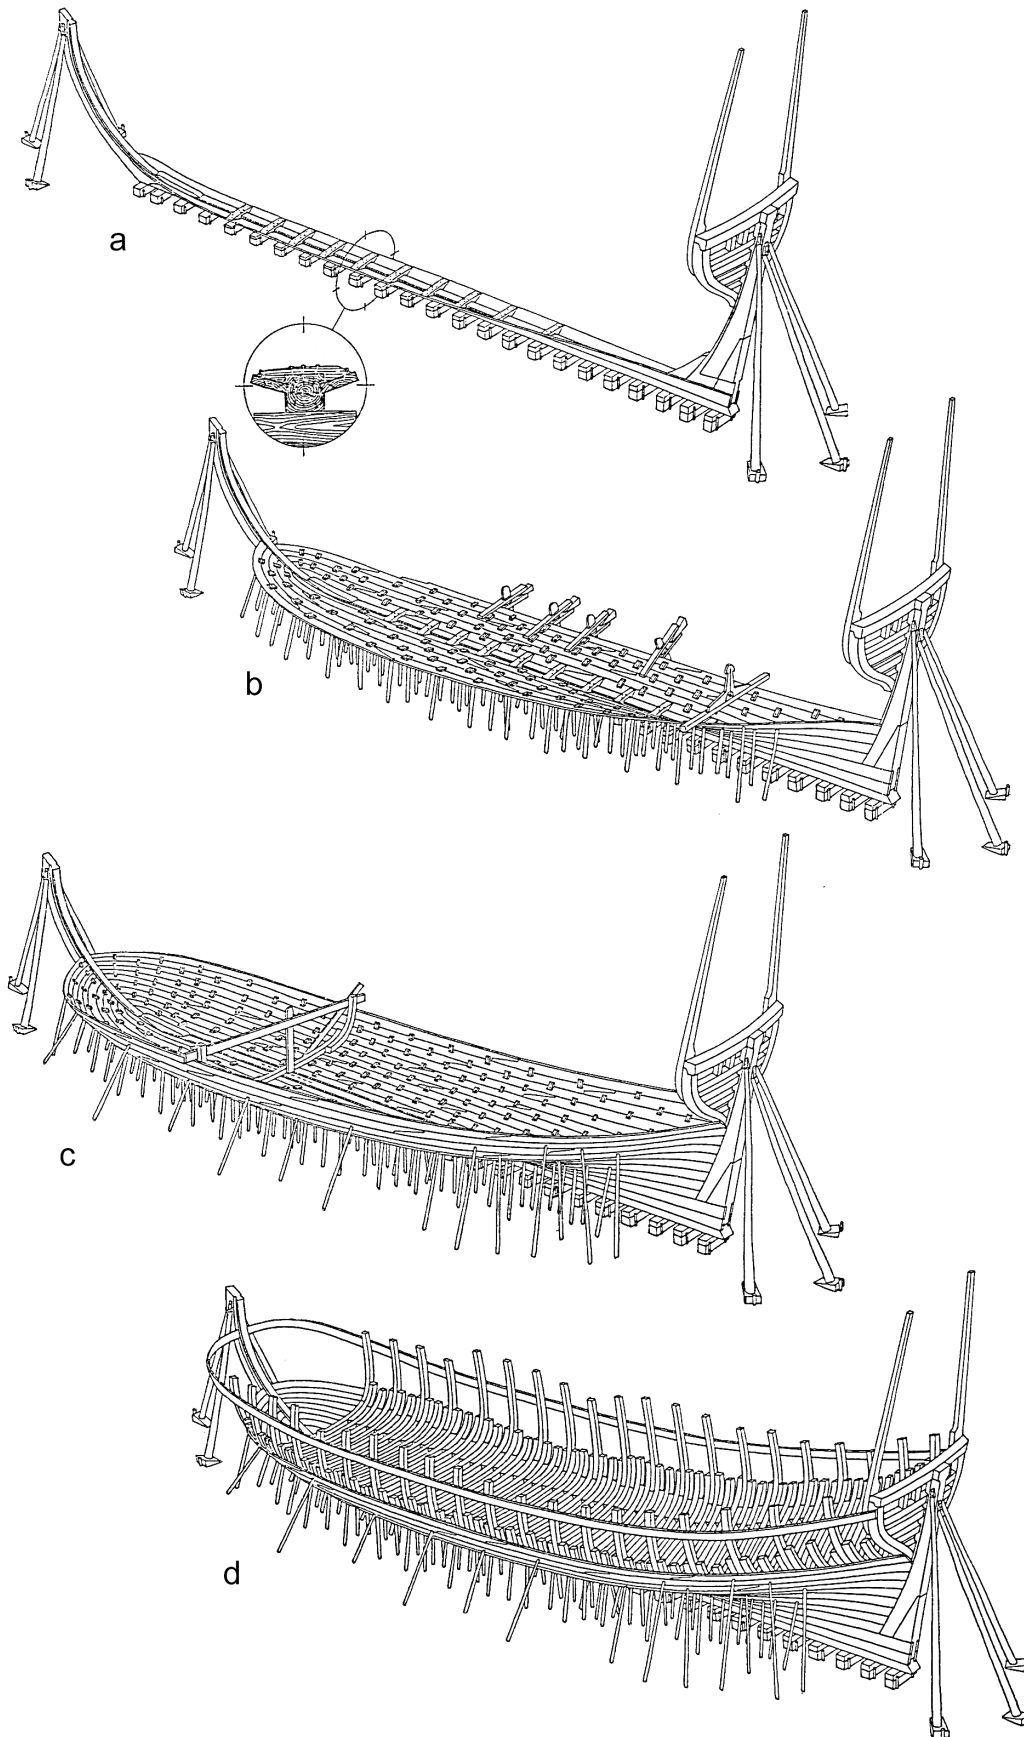
Witsen describes the use of a master frame in Dutch bottom-based construction, which was inserted after the assembly of the bottom planking had been completed (fig. 2-8).¹⁰⁶ One floor and two futtocks were installed in the ship's *hals* (neck) at one-third the ship's length from the stem (fig. 2-8c).¹⁰⁷ According to Witsen, only one master floor with a pair of futtocks was placed on the bottom, but there could have been more. The shape of the frame floor was defined by the hull curvature, and that of the first futtocks by the curvature of the bilge. The shipwright did not define this curvature by drawing a mid-ships mold but based it on the shape of the bottom. Witsen does describe how to draw the dimensions of the master frame on paper, but it is not certain whether such drawings were truly used in the shipyard.¹⁰⁸ According to Ab Hoving, the shipwright may have simply used a batten to record the shape of the bottom to define the curve of the master frame in the *hals*.¹⁰⁹

FIGURE 2-8.
Bottom-based
construction method
as described by Witsen.
Illustration by Anton
van de Heuvel.

Witsen does not provide a complete set of dimensions or proportions, but in chapter 11 he does provide a relatively detailed outline of how a large vessel was built in practice (figs. 2-8 and 2-10). The first step was the assembly of the central spine, consisting of the keel, stem, and sternpost. To make the sternpost, for example, the shipwright cut a piece of timber to the desired length, thickness, and width. Then two battens were laid down at a right angle: one extending straight down from the after side of the post's top end (fig. 2-10c, line *a* to *b*) and one horizontal along the sternpost-keel scarf, forming a right angle with the first (line *b* to *f*). After having confirmed with a carpenter's square that the two battens were placed at a right angle, the shipwright marked off points *e* and *f* in case the two battens shifted. The only dimension given in the description of the sternpost is the rake, which was 1 ft per 6 ft of length of the sternpost, equivalent to nine degrees of rake. Witsen did provide proportions for thickness, width, and length of various timbers that made up the stern assembly, since the assembly of parts and their construction sequence were clearly the focus of the discussion. Witsen specifically mentioned that each timber was shaped on the ground, after which it was erected and attached.¹¹⁶

After garboard strakes were inserted, the bottom was assembled and leveled (see fig. 2-8b). In order to create symmetry on both sides of the keel, a line was strung from stem to sternpost over the centerline of the keel, which was used as a baseline.¹¹⁸ Witsen specifically mentioned that in Amsterdam the bottom planks dictated the shape of the vessel. The bottom planking of the ship comprised approximately two-thirds of the ship's total breadth (see fig. 2-8b).¹¹⁹ Witsen explains that the bottom planking of the hull was tightened or pressed together with a chain and lever (fig. 2-10b) and then temporarily fastened with wooden cleats held in place by iron nails (figs. 2-10 and 2-11). Upon removal of the cleats and nails, the nail holes were plugged with square wooden pegs (*spijkerpen-nen*, or nail plugs). These nail plugs have been found on the archaeological remains of all Dutch-built ships dating to the late sixteenth and seventeenth centuries.¹²⁰ In addition,

After these second futtocks were properly installed, additional second futtocks were added to the hull at every fourth frame (see fig. 2-8b). To these futtocks, a *scheerstrook* (sheer strake) was fastened, which served as a master ribband that defined the sheer of the first deck and the vessel. On this ribband, the deck beams and placement of gun ports, masts, and hatches were marked off.¹²⁴ Then deck beams and temporary beams were

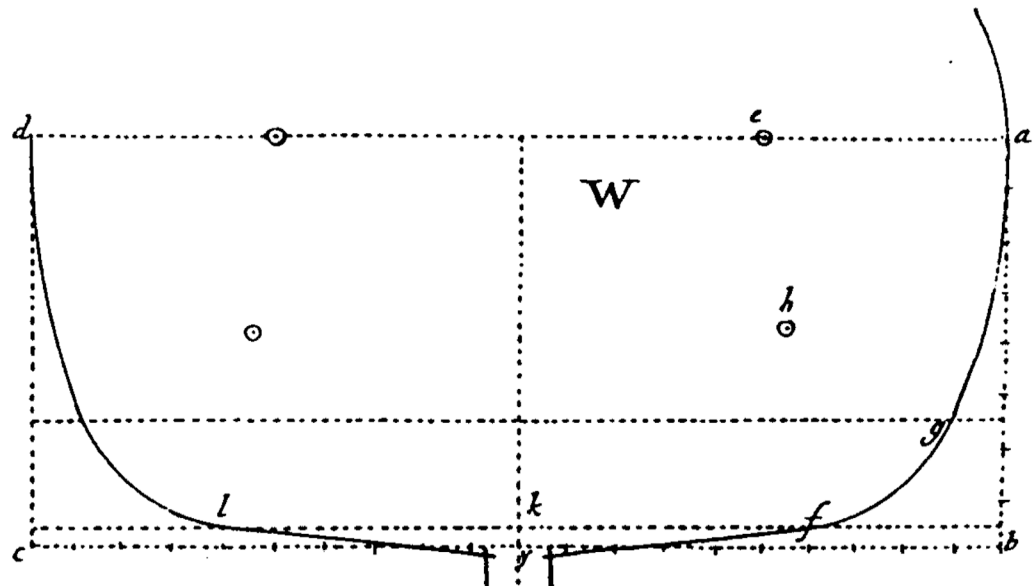
Figure 2-9 illustrates the design of the master frame: horizontal line *a-d* corresponds to the deck level, the curves are drawn from points *e* and *h* with a pair of compasses, *f* and *l* indicate the height of the bottom, *y* is the keel, and *k* denotes the location where the keelson and floors are placed. Witsen explained that to assure the proper curve of the futtocks and the bilge of a model or on paper, a vertical line should be drawn from the

FIGURE 2-9. Midships section as described by Witsen. Illustration from Witsen, *Architectura navalis et reginem nauticum*, numbers LII, W.

center of the deck ($a-d$) through the center of the keel, and the width of the deck should be divided into four equal sections. Unfortunately, the dimensions for Witsen's master frame are not complete. He noted that points f , k , l , and y indicate the rising of the ship's bottom and point f is situated three-fifths of the breadth from the centerline of the keel, but he does not indicate the distance of point f from the lower end of the line it is on. He also mentions that point g is situated approximately two-thirds down from the deck level. The curvature of the first futtock may or may not have been drawn with a pair of compasses from point f to g . Witsen did not specify the radius for the first futtock but indicated that arcs of the same radius were swung from point f and from point g . The curve from f to g was drawn from point h , the intersection of both arcs. Witsen did not discuss the method and radius used to swing the curve between points g and a from point e . In addition, the two arcs were not tangent as is indicated by Witsen's illustration. More interesting is that Witsen's master frame was actually nothing more than a simple section; it indicates the combined curvature of the floor and futtocks as well as the rising of the bottom planking from the keel.¹¹⁰ The latter is different from the curvature of the floors—the garboard strakes were angular and did not sit flush against the floors.

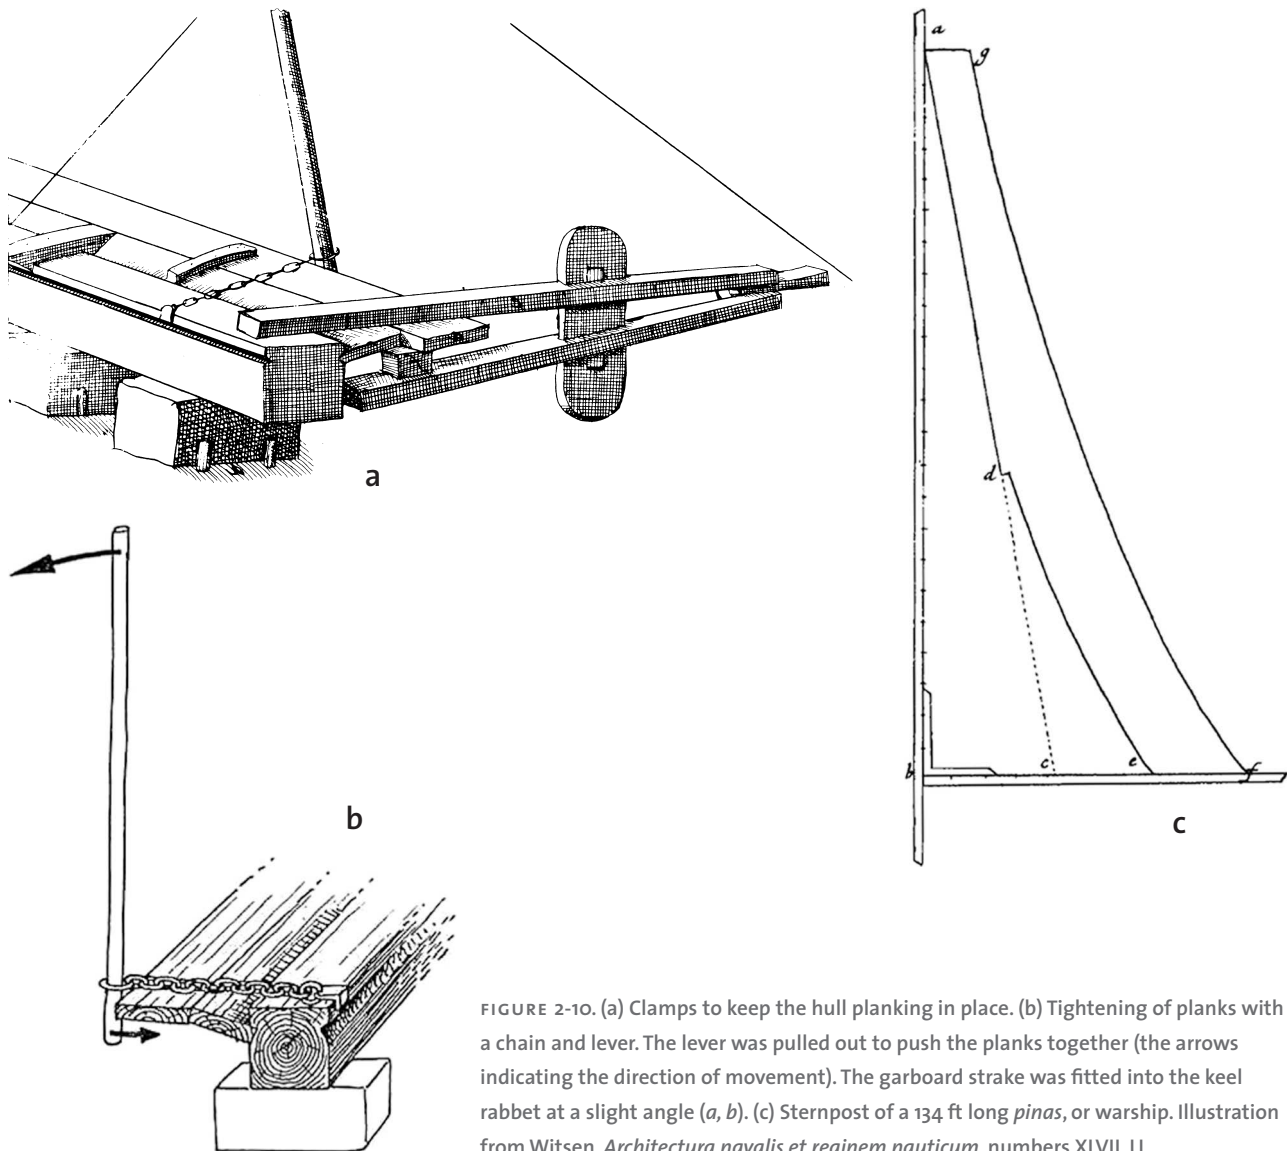
FIGURE 2-10. (a) Clamps to keep the hull planking in place. (b) Tightening of planks with a chain and lever. The lever was pulled out to push the planks together (the arrows indicating the direction of movement). The garboard strake was fitted into the keel rabbet at a slight angle (*a, b*). (c) Sternpost of a 134 ft long *pinas*, or warship. Illustration from Witsen, *Architectura navalis et reginem nauticum*, numbers XLVII, LI.

the keel, which according to Witsen facilitated pumping the water out of the hull (fig. 2-10a, b).¹¹⁷

large wooden clamps were used to keep the hull planks in place and prevent them from bending or slipping downward (see fig. 2-10a). The planks of the vessel were flexed or bent into shape by heating them over fire and then set in place. On the exterior, the bottom planking was supported or propped by wooden shores (fig. 2-12).¹²¹ While cleats, clamps, and shores may have exerted a fair amount of force, they did not provide as solid a foundation for the hull planking as a rigid pre-erected framework did.¹²²

The oak keel, consisting of three pieces of timber scarfed together, has a molded dimension of 42 to 43 cm and a sided dimension of 39 to 42 cm. It has a double rabbet, as do the Scheurrak SO1 and Christianshavn B&W 2, to accommodate the two layers of oak hull planking.⁸⁶ The ship's planking is sheathed with a layer of pine below its waterline.⁸⁷ The angle of the upper rabbet is about 60 degrees, and the lower one, 75 degrees (fig. 5-19). The garboard strakes of Dutch ships are usually angled, as illustrated by the Scheurrak SO1 (1590s) and Scheurrak T24 (post-1655).⁸⁸ According to Witsen, this is important, as water can be pumped out more easily when the garboard strakes have some angle (see fig. 2-10a, b).⁸⁹

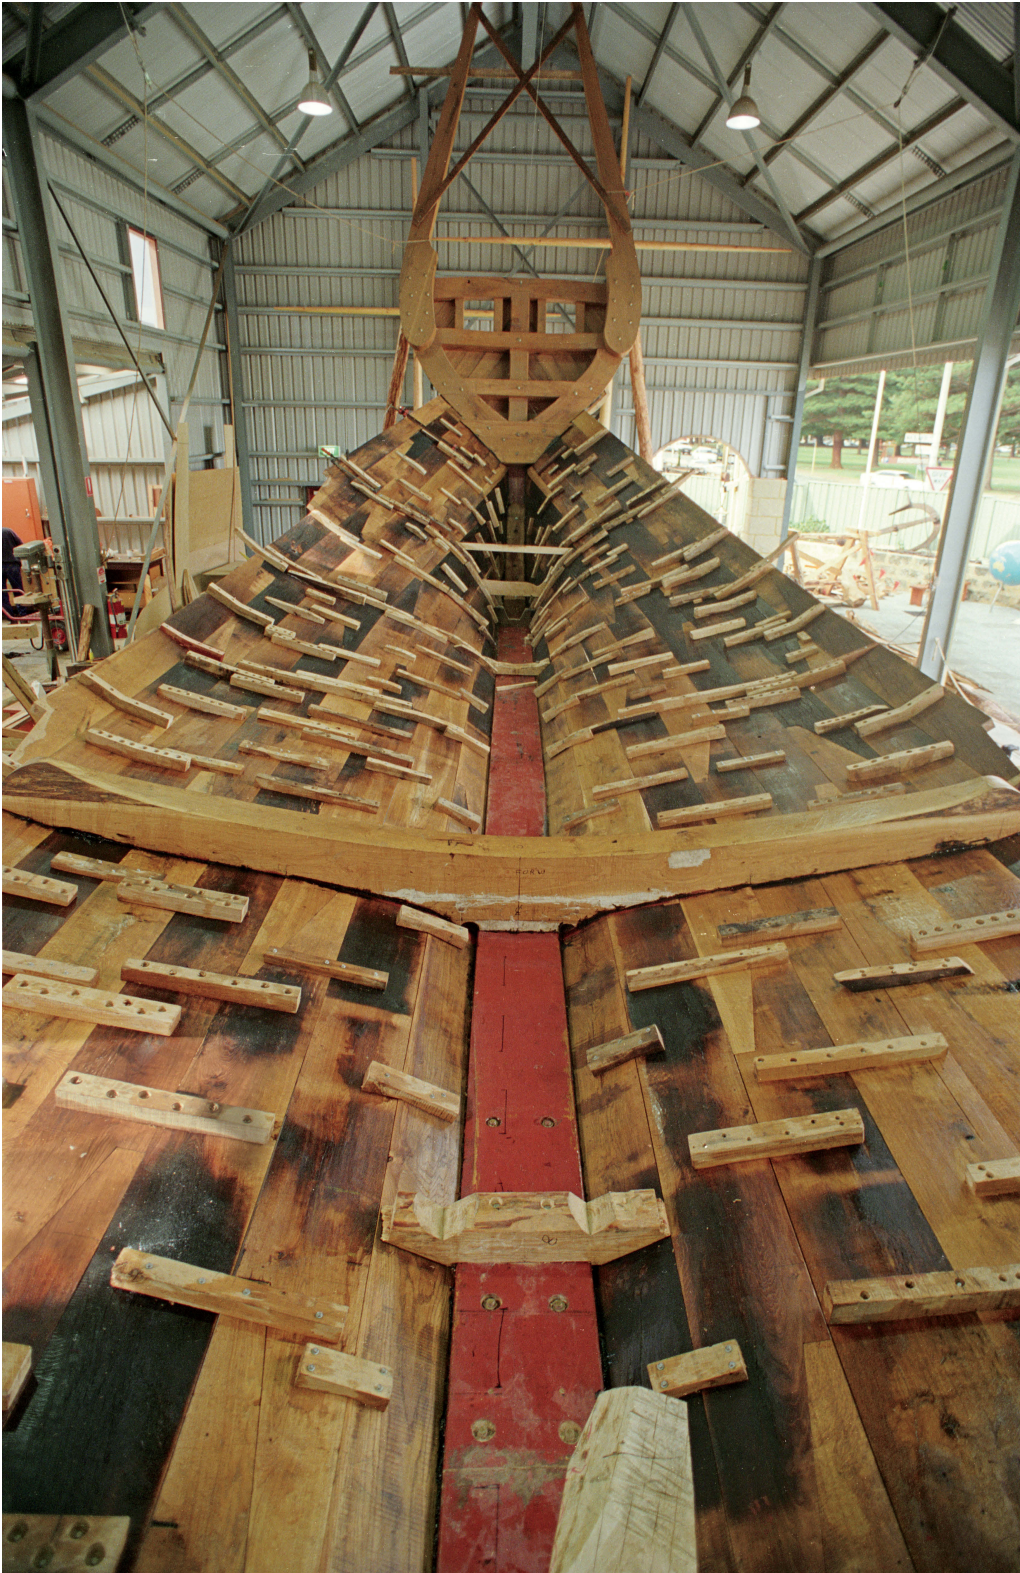
FIGURE 2-11. Temporary cleats used in the assembly of the ship's bottom hull planking during the reconstruction of VOC ship *Duifje*. Photograph by Patrick Baker, Western Australian Museum (MA4871-10).

On *Batavia*, the areas of so-called charring are located on the interior face of strakes 11 and 12 in the inner layer of hull planking and on the interiors of strakes 1–3 in the outer layer of hull planking (see figs. 4-10 through 4-13). The alleged charring on the interior hull planking (strakes 11 and 12), however, is confined to areas directly underneath the frames (figs. 4-86 and 4-87). The staining matches the frames' sided dimensions precisely and, therefore, does not conform to more widely spread burn patterns typical of charring (see fig. 2-11).⁹¹

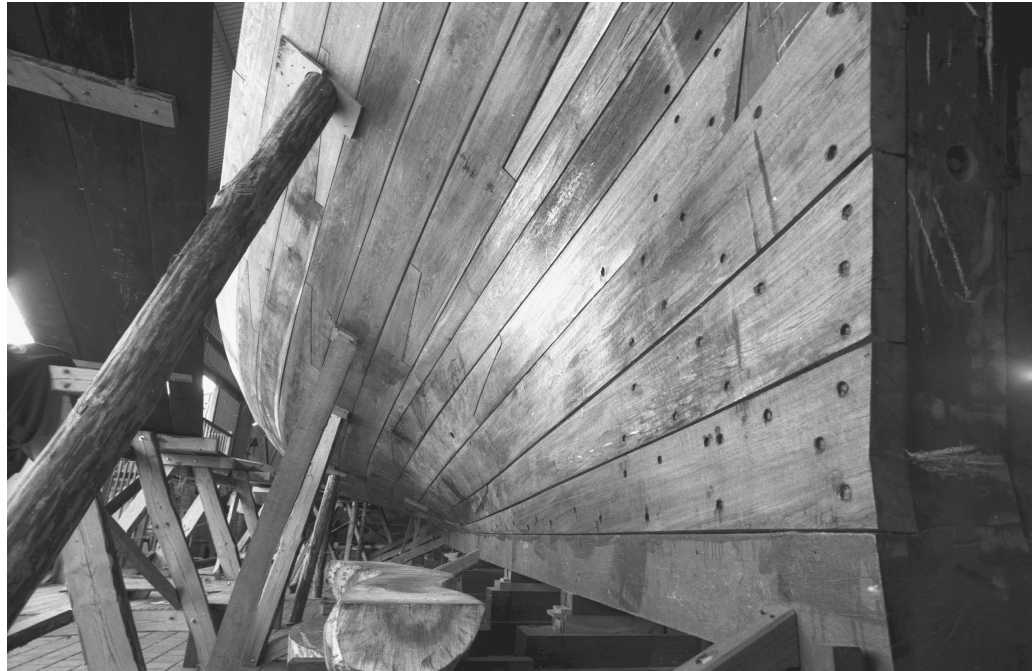
FIGURE 2-12. Wooden shoring poles used on the outside of the ship's hull to support its planking, and temporary cleats used to keep the planking in place during the reconstruction of VOC ship *Duifje*. Photograph by Patrick Baker, Western Australian Museum (MA4868-11).

Additionally, nail plugs have been observed in the outer layer of hull planking on the side of the ship that continues onto the transom (see fig. 4-23, BAT 6413). Here, temporary cleats were probably used to prevent the shoring poles from shifting during the ship's construction (see fig. 2-12).

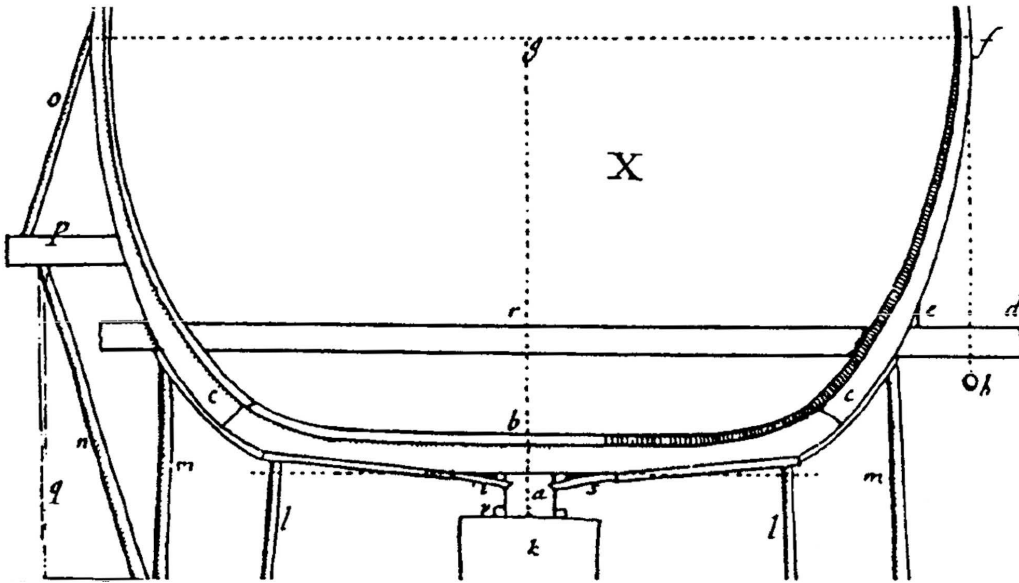
As mentioned earlier, a master frame consisting of one floor and two futtocks was installed in the ship's *hals* at one-third the ship's length. After the remaining floors and first futtocks were installed, the bilges of the ship were planked. The uppermost plank of the bilge planking was placed at one-third the height of the hold.¹²³ Then a transverse beam was laid on the planking edge (fig. 2-13, beam *d*), and the second futtock was fitted on but not attached to the master frame in the ship's neck. A plumb line was dropped from the center of the two futtocks (*c*) over the centerline of the keel (*gb*). From this line, the width between the two second futtocks was measured to ensure symmetry on either side of the keel (the distance from centerline *bg* to the sides *f*). Subsequently, a plumb bob (*h*) was dropped from *f* to check whether the second futtocks flared the same distance out from the bilges.

FIGURE 2-13. Master frame after insertion of second futtocks as described by Witsen. Illustration from Witsen, *Architectura navalis et reginem nauticum*, numbers LII, X.

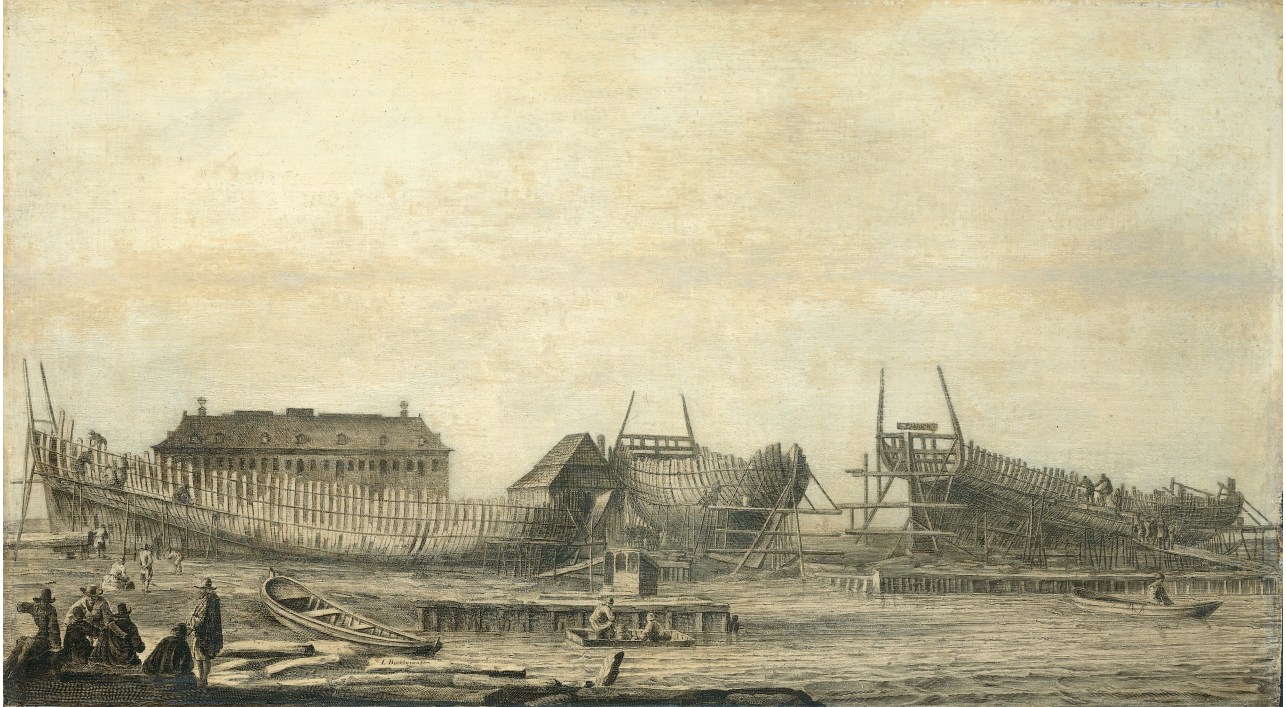
FIGURE 2-14. The shipyard of the Amsterdam Admiralty with three warships being constructed using the frame-based method. Ink on painting by Ludolf Bakhuysen, 1655–60, Rijksmuseum Amsterdam (SK-A-1428).

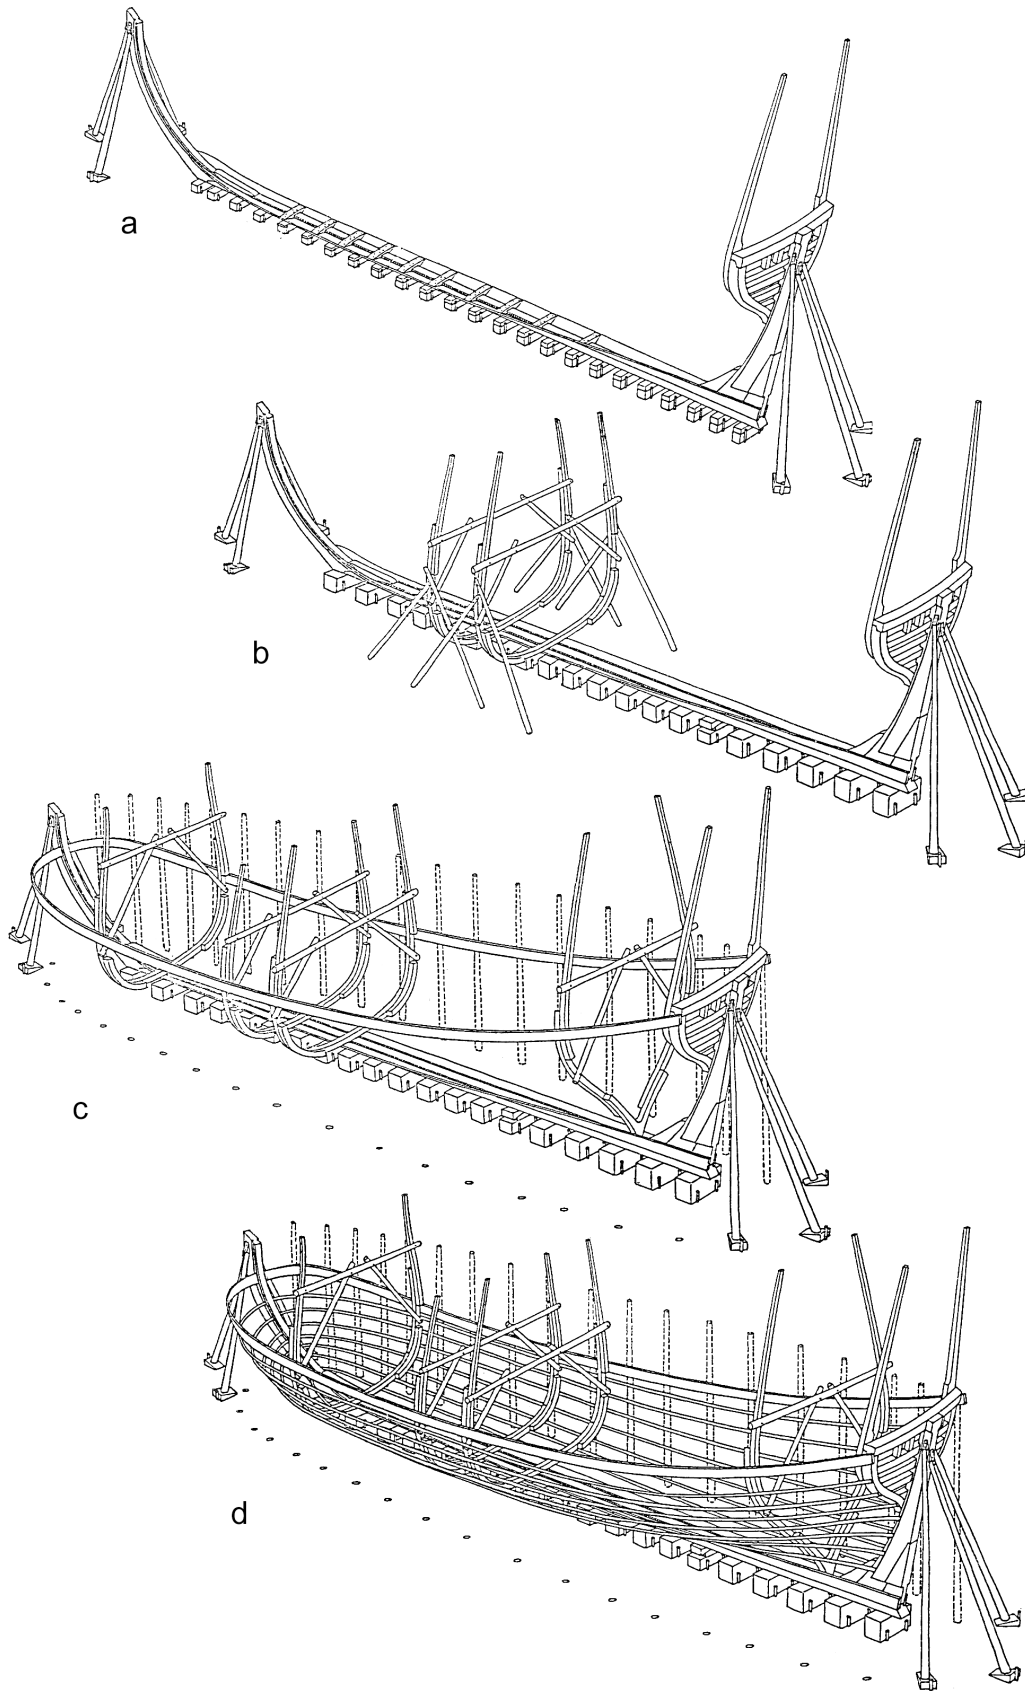
FIGURE 2-15.
Frame-based
construction method
as described by Van IJk.
Illustration by Anton
van de Heuvel.

Van IJk described the design and construction of a complete vessel from step one, as Nicolaes Witsen did, but for a frame-based construction method. Similar to Witsen's construction sequence, the garboard strakes were inserted after the keel was laid and the central spine was assembled (fig. 2-15a). Where Witsen discussed the assembly of the ship's bottom planking, Van IJk continued with the erection of two full main frames consisting of seven timbers each: one floor, two first futtocks, two second futtocks, and two third futtocks (fig. 2-15b). The first pre-assembled main frame was placed at a measured distance from the stem: the sum of half the length of the hull and half the length of the stem. The second one was placed at one-quarter the distance from the first frame to the beginning of the stem. Between these two frames, the shape of the hull did not change. Van IJk did not discuss the design of the two master frames or their dimensions. The curvatures of both frames depended mainly on the beam and depth of the vessel

Next, vertical poles were driven into the ground around the ship to define the sheer line or the shape of the hull from a bird's-eye view (fig. 2-15c). In addition, a second row of poles was inserted to allow the construction of scaffolding and create a working platform for the upper parts of the hull. On the interior of the first line of poles, the shipwrights fastened the sheer strake or main ribband. Van IJk specifically mentioned that the main ribband was sometimes used to build several similar vessels, as the deck beams, placement of gun ports, masts, and hatches were marked off on it. After this main ribband was fastened, a third full frame was inserted on the scarf of the keel and the stem. The distance from the stem to this new frame was measured, and an end frame was placed at the same distance from the sternpost. Subsequently, 8 to 10 ribbands, depending on the size of the vessel, were placed on each side of the hull between the garboard strakes and main ribband. The ribbands ran the entire length of the hull. They determined the final shape of the hull and indicated the curvature of each hull planking strake. They were also used as a mold for the curvatures of the remaining frames. According to Van IJk, the master shipwright shifted the ribbands up and down along the sides until he was satisfied with their shapes.¹³¹

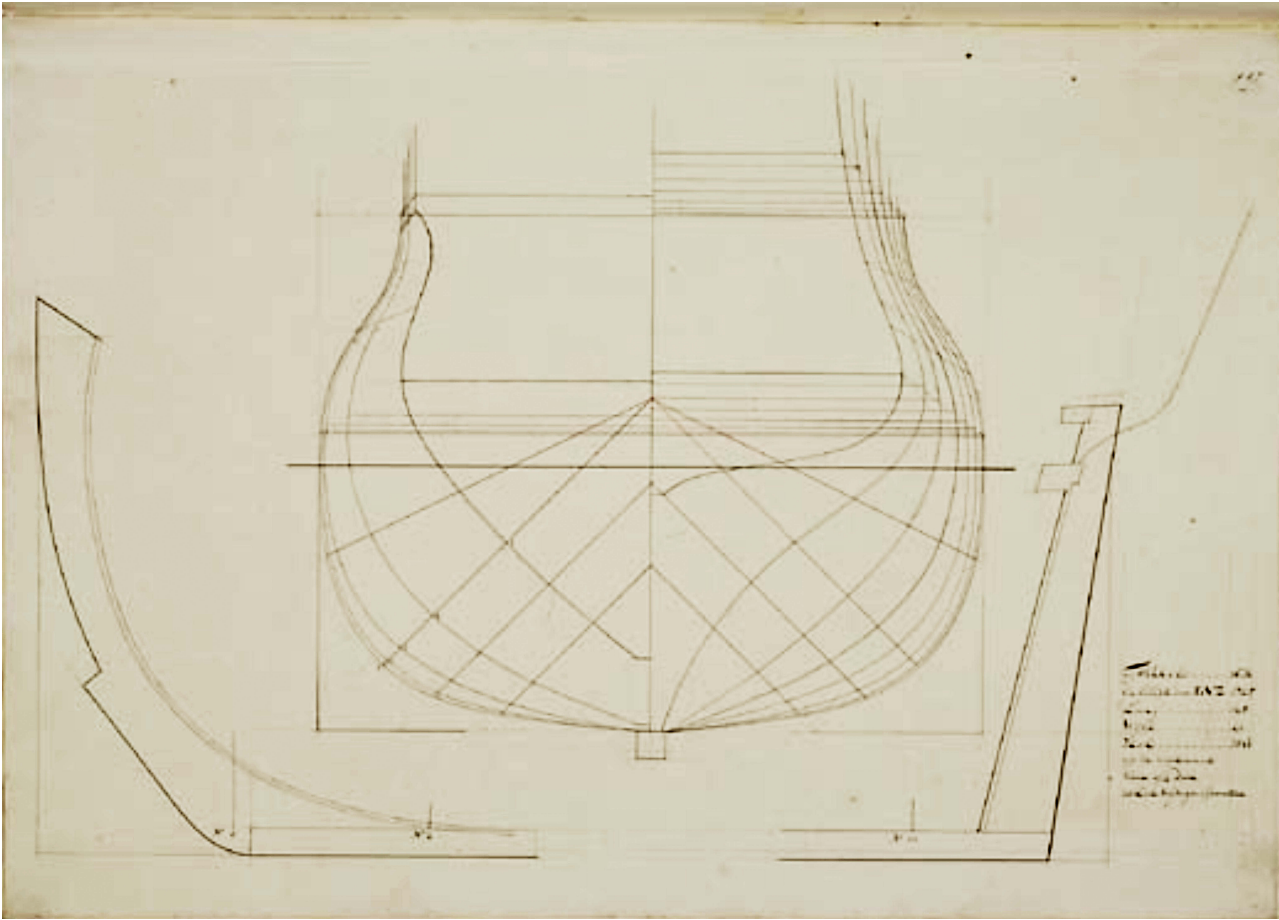
FIGURE 2-16. Body plan of *Twikkelo*, with diagonals, stem, and sternpost, built by Paulus van Zwijndregt in 1725. Illustration by Paulus van Zwijndregt, Maritime Museum Rotterdam (T1126-37).

It is not known exactly when Dutch shipbuilders brought the frame-based construction method, described by Van IJk, into their shipyards, but it must have been some time after 1650 and became established by the early eighteenth century in all major Dutch shipyards. The first body plan of a warship that survived was drawn in 1725: it shows diagonals, as well as a stem and sternpost. This warship, *Twikkelo*, was built by shipwright Paulus van Zwijndregt for the Rotterdam Admiralty (fig. 2-16). It measured 145 ft in length, 41 ft in breadth, and 18 ft in height and carried 56 guns.¹³² By this time, Dutch shipwrights had learned to work with drawings. It had been one century since bottom-based construction had become the foremost method of shipbuilding in the Netherlands. At the time *Batavia* was built in the VOC shipyard of Amsterdam in the late 1620s, frame-based construction was not yet used in that region.

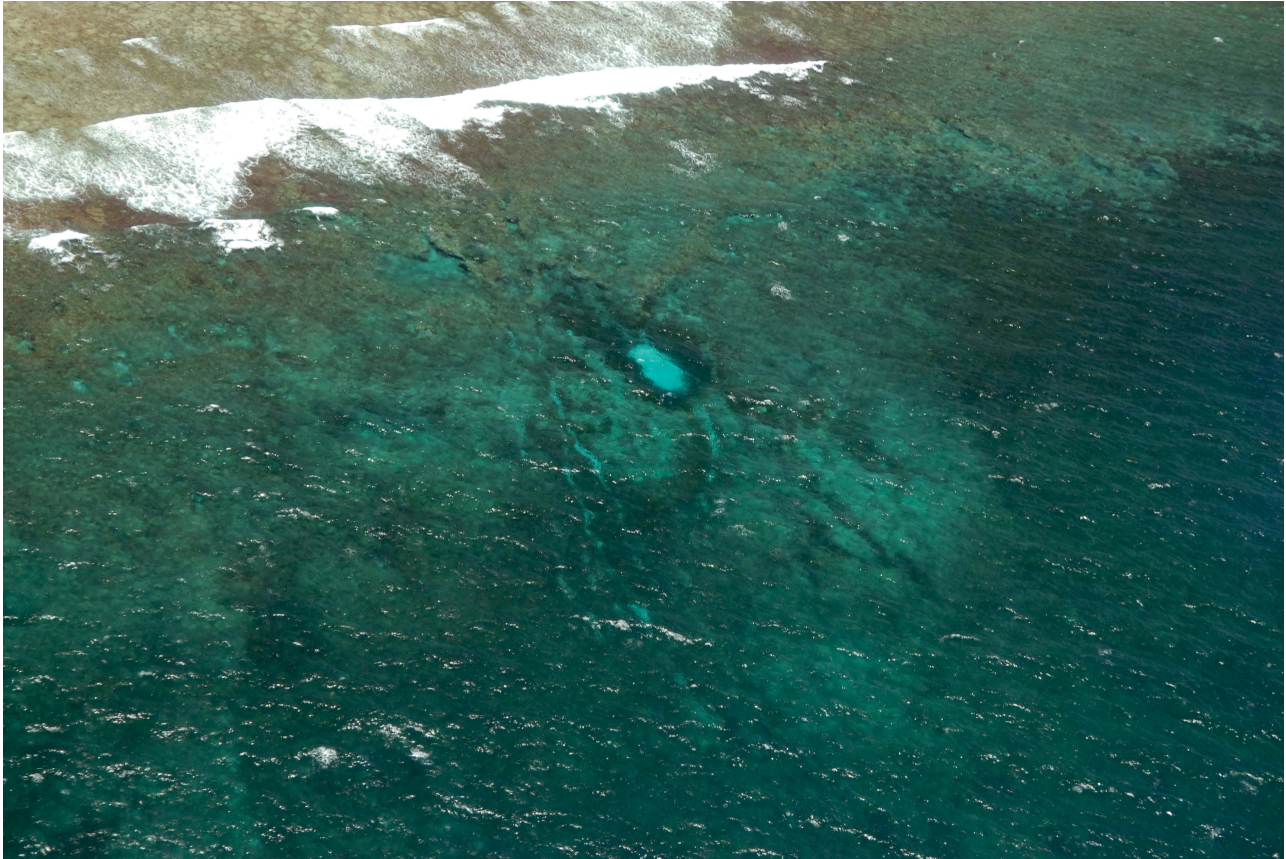
FIGURE 3-2.
Morning Reef and the
Batavia shipwreck
site. Photograph by
Patrick Baker, Western
Australian Museum.

The Houtman Abrolhos is an archipelago of islands and reefs situated about 60 km off the Western Australian coast. It includes one distinct island and three main island groups: North Island, the Pelsaert Group, also known as the Southern Group, the Easter Group, and the Wallabi Group (fig. 3-1). The remains of the *Batavia* lie at a depth of 3 to 7 m at the southwestern end of Morning Reef in the Wallabi Group. The wreck site covers an area of about 50 m in length and 15 m in width and is oriented in a north-south direction, with the ship's bow at the northern end on top of the reef edge in the shallower part of the site (figs. 3-2 and 3-3).

One kevel, or belaying cleat, has been preserved attached to the uppermost transom knee on the after lower deck directly below the wing transom, where it was fastened to the interior corner of transom knee BAT 6223 A with iron spikes (see figs. 3-2, 4-73, and 4-76). The kevel, BAT 6220, is made up of three oak sections, and the entire assembly measures 86 cm in length, 55 cm in width, and 8.8 cm in thickness. It was mainly used to belay the stern mooring line or tow line for *Batavia*'s boat.
